Overview of Alarm Issue Observed on Original 21CN Voice Trial

Technical Note

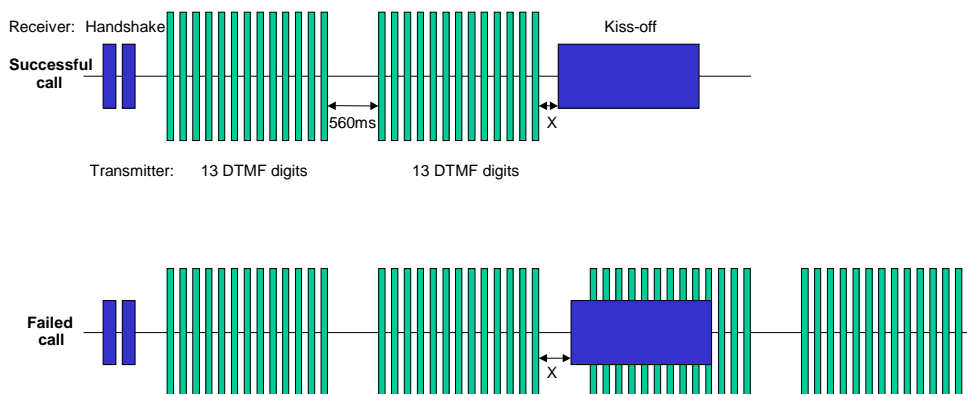
Fig 1. Successful and Unsuccessful Call Traces (Transmitter End)

Figure 1 shows examples of successful and failed calls captured in the previous investigation. A successful call is shown in the top diagram of Figure 1. Data was captured at the customer premises (alarm communicator), so the high amplitude (green) signals are from the CPE, and the low amplitude (blue) signals from the central station receiver. The receiver answers the call with a dual-tone handshake signal, after which the communicator sends a string of 13 DTMF tones identifying itself to the receiver. This digit string is repeated as an error check and if the receiver identifies both digit strings as being the same it issues a 1400 Hz kiss-off tone to acknowledge receipt and clear down the call.

A failed call is shown in the lower diagram. In this case the receiver receives the first two sets of digit strings and issues its kiss-off tone, but for some reason the customer’s alarm transmitter fails to detect the kiss-off tone and so repeats the digit strings a further two times before clearing down. The result of receiving the additional digit strings causes the receiver to report a “Fast Format Error”. This is probably because the third digit string is partially masked by the kiss-off tone, which is at a much higher level at the receiver than the digit string.

Increased round trip delay resulted in the CPE starting its second transmission attempt before recognising the kiss-off relating to the first transmission sent from the central station. At the central station receiver, the second DTMF transmission arrival overlapped with the outgoing Kiss-off (for the first reception). It appears the central station receiver was not able to receive the DTMF re-transmission in the presence of its outgoing Kiss-off, so indicated an error. Theoretically, it should be possible for it to receive DTMF in the presence of its outgoing Kiss-off, but from the above details it is not surprising that it fails. Therefore, as noted above, we should assume such half duplex operation for

DTMF, and the majority of the other alarm communication methods also appear to be half duplex. This means that round trip and equipment timings need to ensure no clashes between transmit and receive occur at either end. This is cannot easily be guaranteed, except by slowing everything down to accommodate worst case delays and this will usually need changes to software timers in the equipment at both ends.

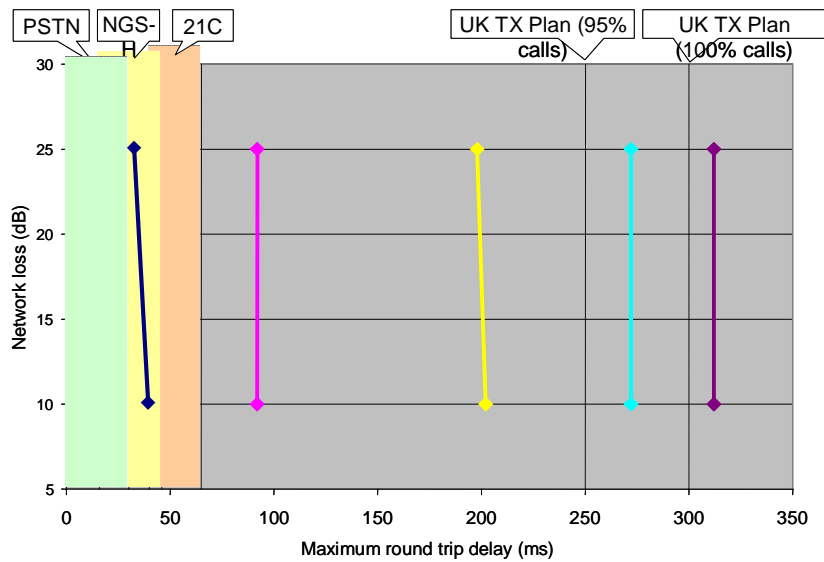
Fig 2. Performance of different Digital Communicators with network delay and loss

The previous investigation quantified the delay issues for five different models of customer transmitters and two central station receivers. These results are summarized in Figure 2.

THE GRAPH SHOWS THE LIMIT OF RELIABLE WORKING FOR EACH OF THE DIGITAL COMMUNICATORS AS A FUNCTION OF ROUND-TRIP NETWORK DELAY AND OVERALL END TO END NETWORK LOSS. IT ALSO SHOWS THE TYPICAL ROUND-TRIP DELAYS EXPECTED FROM DIFFERENT NETWORKS AND THOSE ALLOWED BY THE UK TRANSMISSION PLAN. .

- For calls entirely on the 21CN Voice Trial, only one out of the five customer alarm transmitters investigated appeared likely to have a problem. The unit appears to be already very close to the limit for reliability on the present PSTN and is likely to have a problem at present if routed over another network, for example by the use of Carrier Pre-Select.

- For call delays at the limit of the UK transmission plan, four out of the five customer alarm transmitters investigated would experience a problem. Such calls would imply routing over other networks in addition to the 21CN and the majority of the extra delay comes from such routing (i.e. the contribution of the 21CN is quite a small part of the total). Some of the newer equipment probably tolerates longer delays because it is also designed for reporting over the cellular network.

- The central station receivers contribute significantly to the overall round trip delay as experienced by the alarm transmitter. This is something the alarm industry might be able to address: it forms a substantial part of the overall delay budget, there are relatively few receivers and they are located at the central stations.
